Major Cowling Creek Barriers

The Wild Fish Conservancy watertyping project produced an interactive map that shows several barriers along the creek, which is available at <http://wildfish.beardedmaps.com/?lat=47.785&lng=-122.54&zoom=12>. Screen captures of that work (edited with specific locations) show the barriers along the stream.

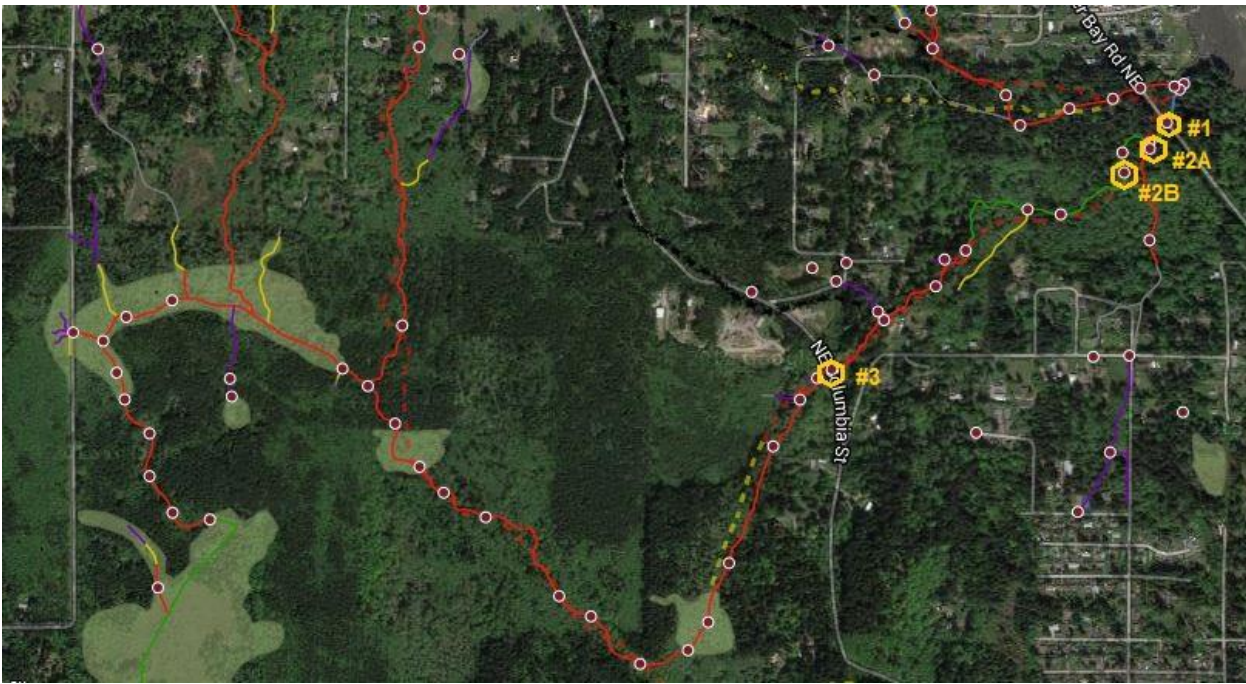
- #1 The focus culvert under for the Cowling Creek Culvert replacement Feasibility study
- #2A and #2B Historic chum hatchery creates a barrier. A fish ladder allows salmon to pass.
- #3 Columbia Street culvert. Thanks to Trout Unlimited, a fish ladder now allows salmon to pass.

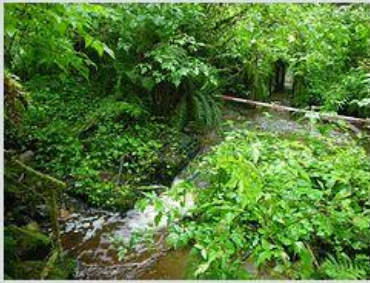
#2A– Historic Hatchery location.

Notes:~2/3 of instream flow passes through an open fishway of the historic chum hatchery structure at Cowling Creek Center, with the other 1/3 entering a pipe that is perched 6 inches above water surface at the opposite end of the old concrete dam. Gravel and s The MB01B "Elder's Tributary" enters MB01-1 South Cowling mainstem from the right bank (lower left in photo). The opening to the fishway through an old concrete hatchery dam is visible in background. Note wire rock gabions to slow channel erosion.

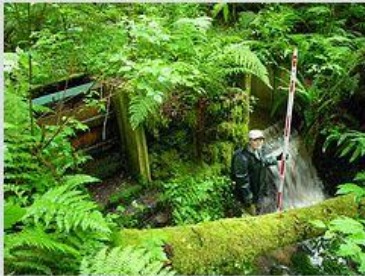
#2B – Hatchery Barrier

Notes:Derelict head dam (part of the infrastructure associated with a former chum salmon hatchery at Cowling Creek Center) captures the entire MB01-1 channel in a concrete-lined fishway with a 4.5 ft. outfall that is a total barrier to upstream fish migration a The perched outlet of an old concrete head dam has a 4.5 ft. outfall that is a total barrier to upstream fish migration along South Cowling Creek. The derelict dam is part of the infrastructure for a former chum hatchery operation at Cowling Creek Center.

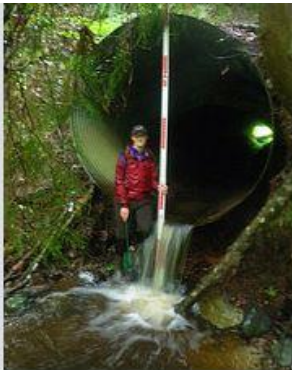
#3- Columbia Road culvert

Notes:Columbia Street NE culvert is a total barrier, preventing fish from accessing all available habitat in the lengthy upper South Cowling watershed. The 7 ft. pipe was "at grade" when first installed, but decades of erosion have undermined the downstream cha The Columbia Street NE culvert has a 2.5 ft. perch 2.5 ft. above water surface at the outlet, creating a total barrier to upstream fish migration into several thousand meters of potential fish habitat along upper South

Cowling Creek and its tributaries.
